# COMPILATION, METALLURGICAL LABORATORY TESTS ADVANCED TECHNICAL DEVELOPMENT EFFORT AND SPECIFIC SPACECRAFT

#### JANUARY 1964

By W. G. Grenier

National Aeronautics and Space Administration Goddard Space Flight Center Greenbelt, Maryland

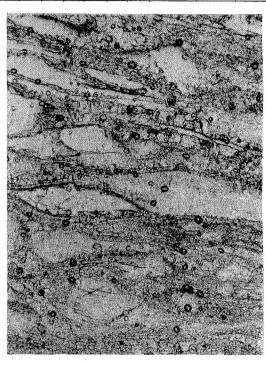
Figure 16

Figures 16 & 17 show the microstructure typical of the flat section indicated in Figure 3. The observed plane is indicated in the sketch above.

The large grains shown in Figures 16 & 17, coupled with the low hardness, indicate that the material is in the annealed condition.

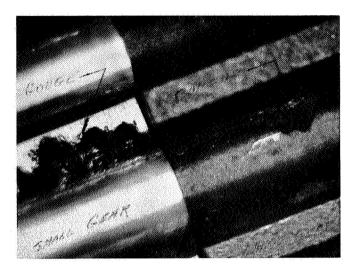
Figure 1 10X

Gear teeth of assembly 2A-2b

Section under study was taken from large gear across area labeled Buildup.
